# LAND DEGRADATION AND REHABILITATION IN MEDITERRANEAN ENVIRONMENTS

## FIELD TRIP

## **Figueiras (Santiago de Compostela) wildfire**

# RECLAMATION OF THE AS PONTES MINE

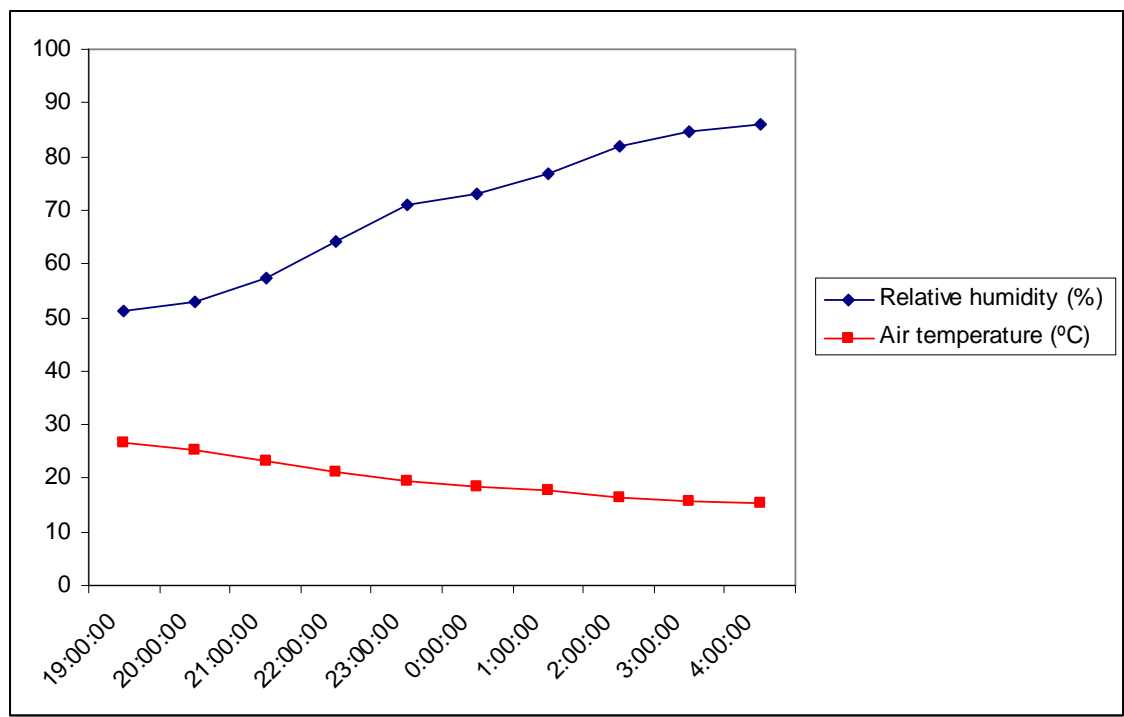
The course of air temperature and relative humidity and wind gust velocity and direction are shown below.

The last rainfall occurred 39 days before fire date. The mean of the maximum daily temperature during that period was 24°C and the relative humidity was 56%. Mean of the wind gust velocity during those days was 37 km/h.

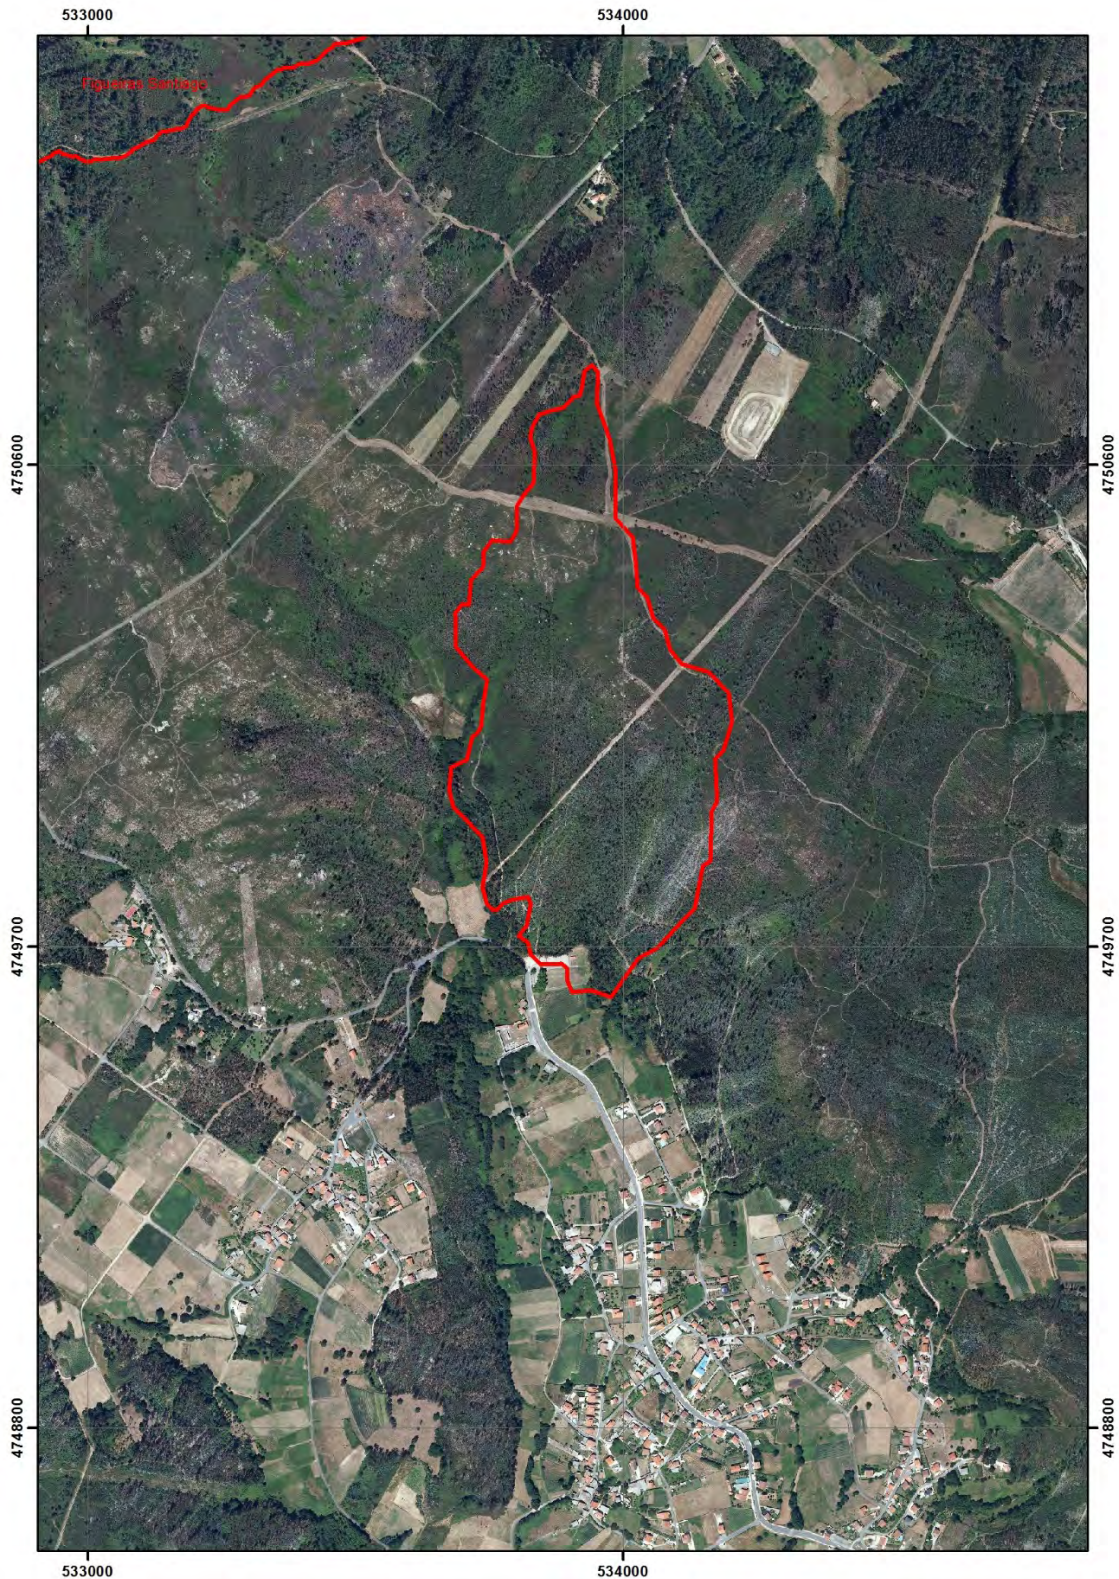
Fire severity map obtained from dNBR index in base of Landsat 8 imagery

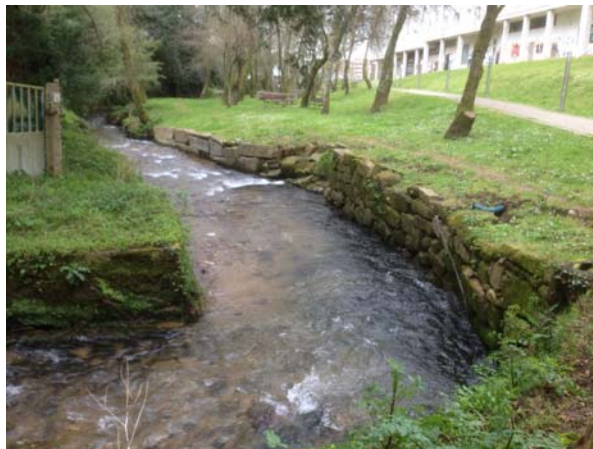
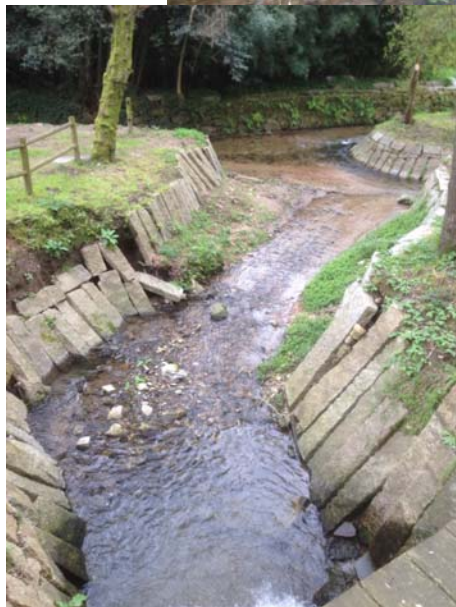
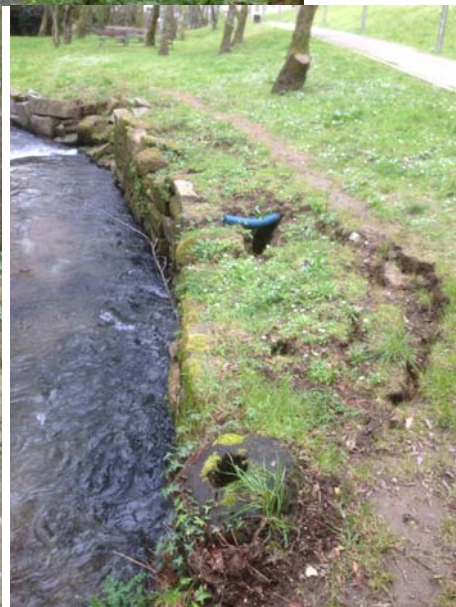
Coca Park (X= 27662 m Y= 4731669 m) Datum ETRS89

- River channel restored some time ago, now showing problems of lateral erosion, mainly in river bends. Reinforced banks were eroded and are falling.
- Krainer wall on one side of a lateral building.
- River completely channelized from this park to the river mouth, placed 1.5 km away.
- Typical channelization problems I this final section.

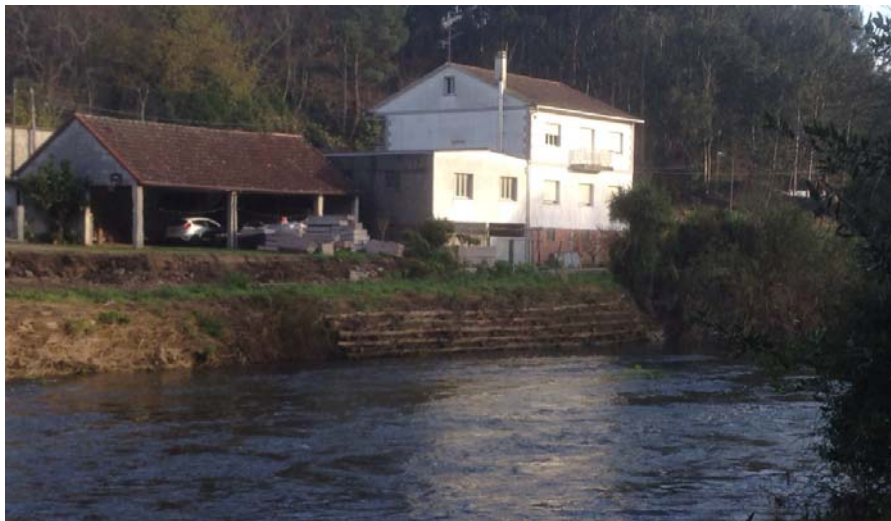
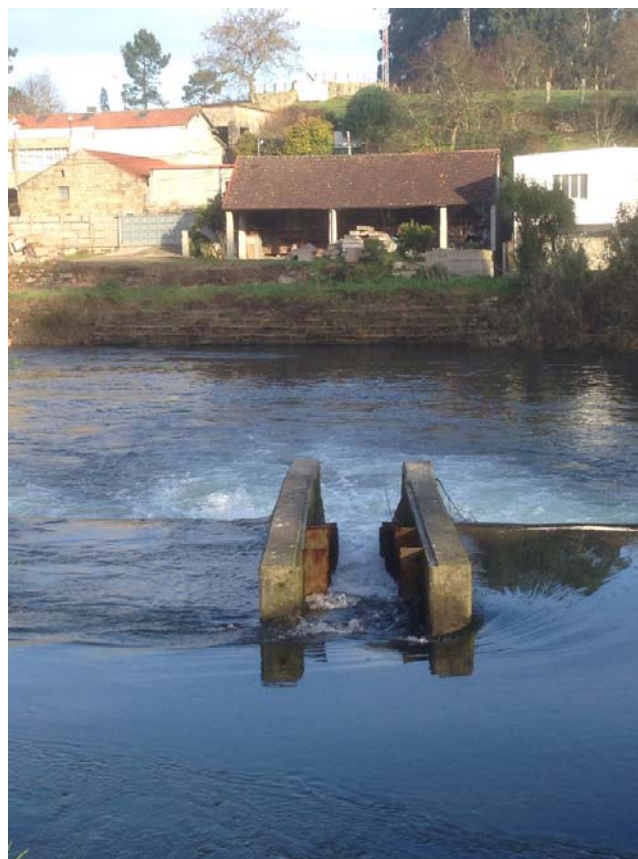
Pontearnelas X= 27647m, Y= 4725280 m)

A small dam was built in the Umia river to provide drinking water to the surrounding area. The current dam was made in a river just before a bend and the river bank faced to the dam was severely eroded. It was stabilized with some rocks for some years but in 2014 rocks were replaced using a wooden log-crib wall system (Krainer walls).

Two small Denil fishways allow migratory fishes to bypass the dam. This style of fishway uses a series of symmetrical close-spaced baffles in a channel to redirect the flow of water, allowing fish to swim upstream. There is also a fish counting device on one side.

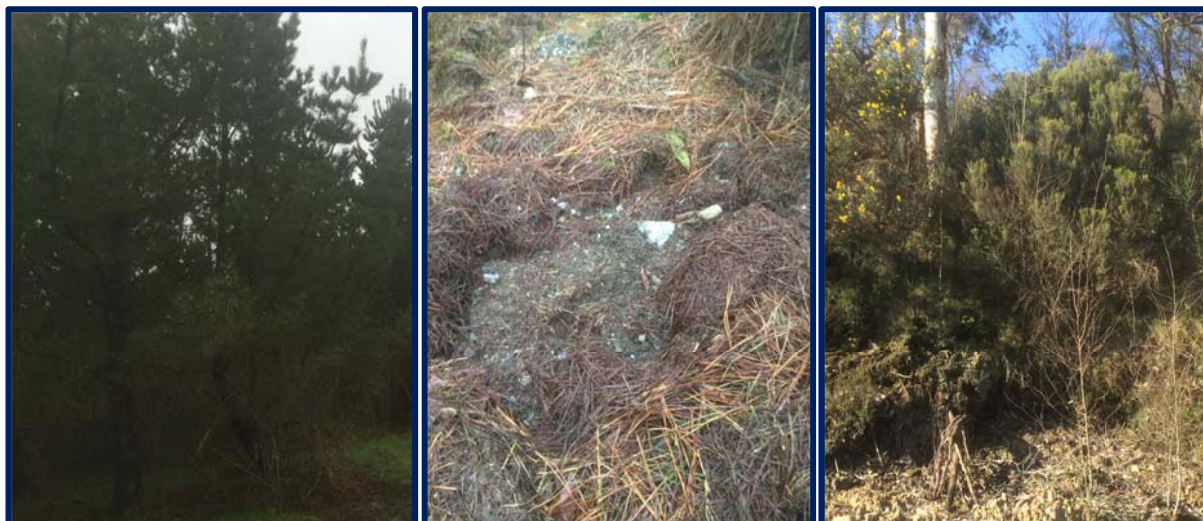
Figure 2. Forest ecosystems

*Castanea sativa*, *Quercus robur*, *Quercus rubra*, *Acer pseudoplatanus*, *Sorbus aucuparia*... or hardwood upgraders of soil such as *Alnus glutinosa*, *Alnus cordata* or *Betula alba* (see Figure 2).

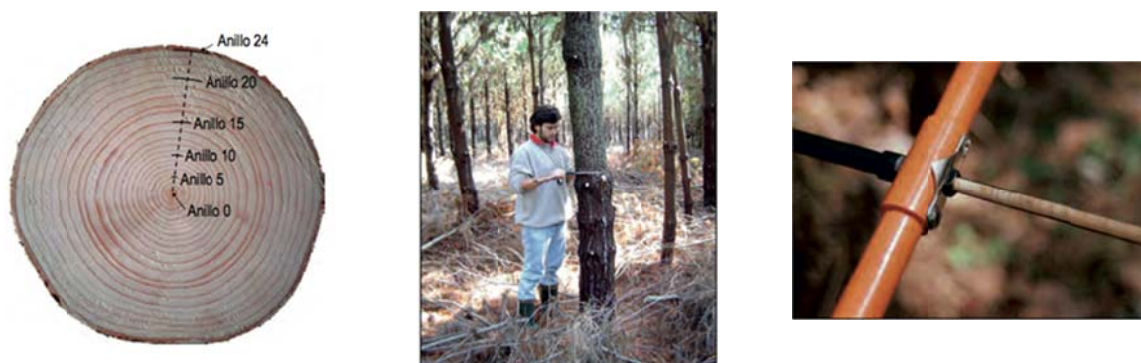
Figure 4. Age estimation

- Measurement of diameter in cross at chest height ( $dn = dn_1 + dn_2/2$ )
- Age estimation (see Figure 4)
- Distance between trees

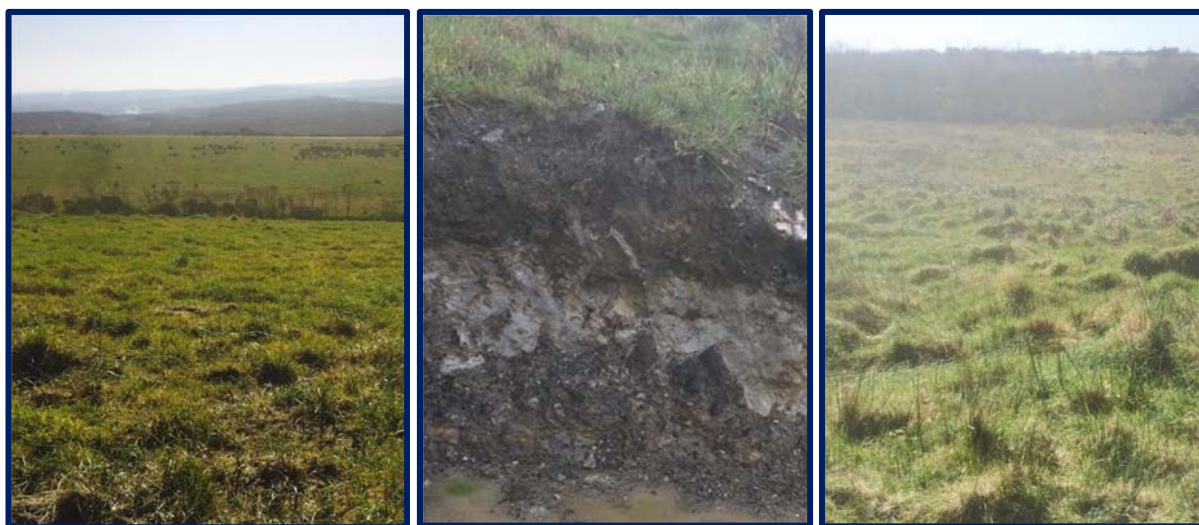
Figure 5. Grassland ecosystems

The first vegetal implantation was carried out with species with important capacity of adaptation and survival such as *Dactylis glomerata*, *Festuca arundinacea*, *Festuca trichophylla*, *Lolium perenne*, *Trifolium pratense* or *Trifolium repens*. These species are the most suitable for the soils of the mine dump, therefore, normally used on degraded land. Later, they began to appear representing spontaneous species of the area as *Holcus lanatus*, *Agrostis capillaris*, *Agrostis castellana*, *Agrostis truncatula*, *Plantago lanceolata*, *Bellis perennis*, or *Lotus corniculatus* forming the end permanent grassland which together constitute an ecosystem that stands out for its biological and landscap features (see Figure 5).

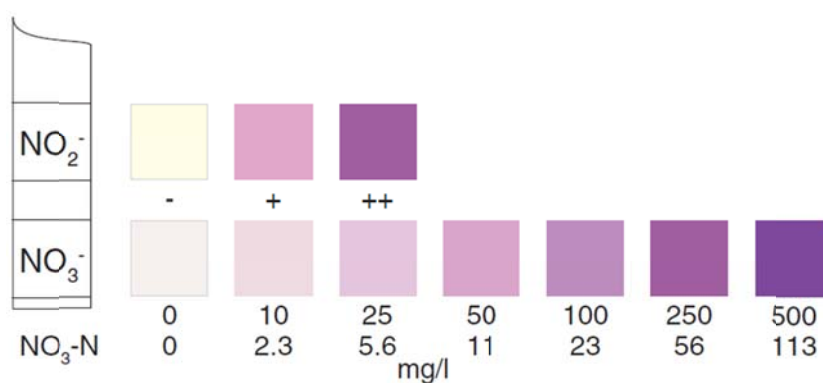
Figure 8. Nitrates colour scale

As happened to pH, the nitrate concentration is measured **semiquantitatively** by visual comparison of the reaction zone of a test strip with the fields of a colour scale (see Figure 8).

Each strip also features a second reaction zone (**alert zone**), the colour of which changes in the presence of nitrite ions.

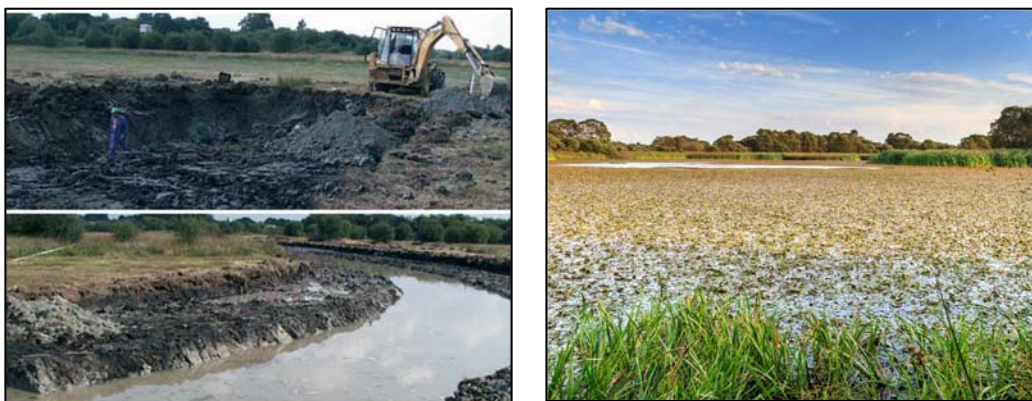
Figure 2. Cospeito lake during (left) and after(right) restoration. Image source: Ramil Rego et al., 2006; Díaz Varela

The interest of this areas is due to the different stage of recovery/evolution after ecosystem restoration actions. Indeed, the main water body of the Cospeito Lagoon was restored at the beginning of the 2000 decade, being a good example of medium-long term stage of habitat recovery (figure 2). In turn, there are several examples of early stages of ecosystem recovery both around the Cospeito lagoon (figure 3) and the St. Roque island (figure 4). These latter restoration actions were executed in the framework of the EU funded LIFE+ project Tremedal.

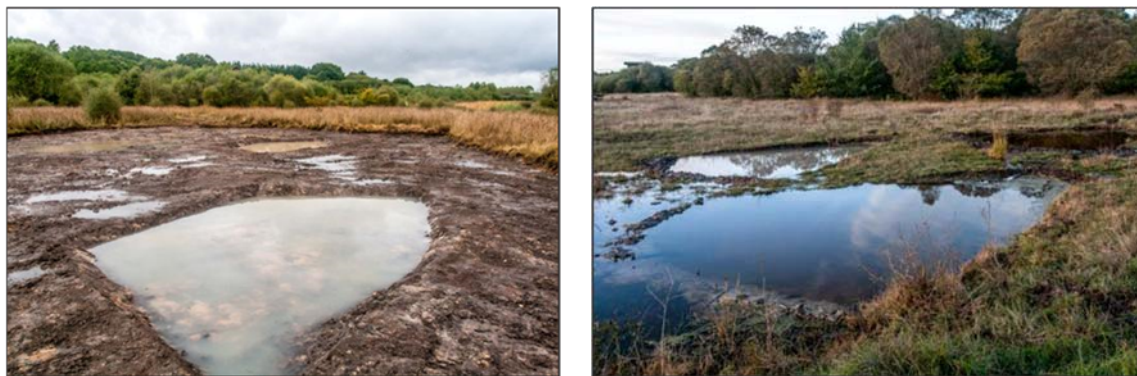
Figure 3. Early stages of vegetation recovery in the ponds excavated in the surrounds of the Cospeito lake.  
Image source: Life Tremedal; Rubinos Román

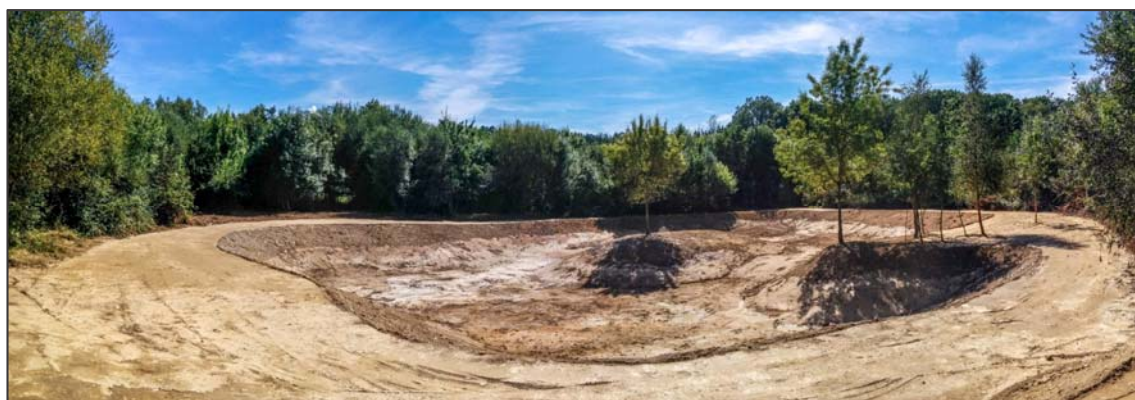
Figure 4. Pond excavated in the St. Roque island. Image source: Life Tremedal; Rubinos Román

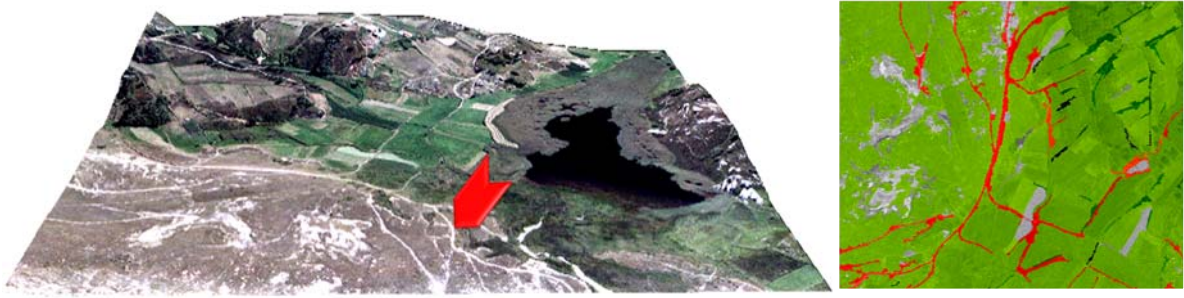
Figure 2. Examples of dune habitat fragmentation due to informal paths and trampling. On the left a 3D block with indication of one of these paths. On the right a map indicating the extend of the paths in a sector of the dunes in the Natural Park. Taken from Diaz Varela et al., 2008. Image source CNIG-IGN, Ministerio de Fomento.

beaches, as the areas eroded of the sand dunes are frequently trampled by summer visitors and require a careful sign and fencing to allow the dune recovery or at least stop the dune degradation.

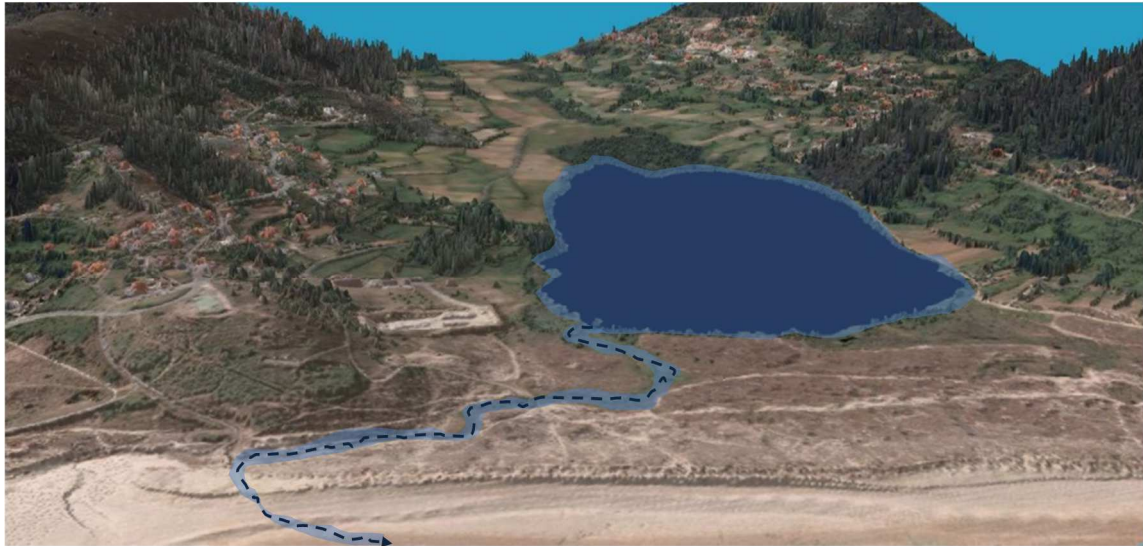
Figure 2. 3D Block representing the water body of the Doniños Lagoon and the approximate path of the channel to the sea crossing the sand dune barrier. (Geographical data from PNOA © Instituto Geográfico Nacional de España).

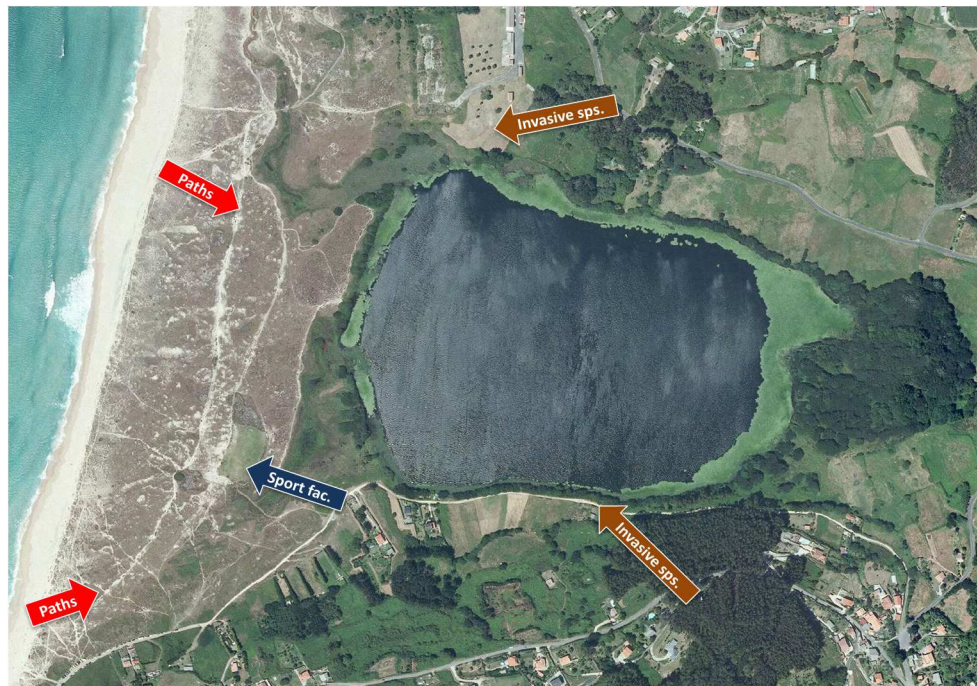
Figure 3. Aerial image and location of some of the environmental impacts in the Doniños coastal lagoon-sand dune barrier system. (Geographical data from PNOA © Instituto Geográfico Nacional de España).
